# TIMING COVER VENT AND DRAIN HOLES

## DOOR LOCKING BARREL

## ENGINE OIL PAN BAFFLE - FITMENT PROCEDURE

# TRUNK LID HINGE REPAIRS

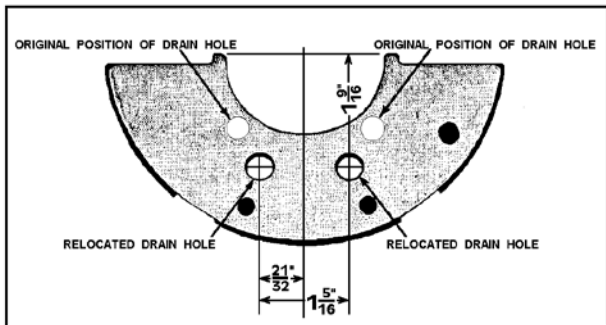
Fig. 1

At approximate engine No. L.313838 ("FE" Sedans) and Engine No. U.313840 ("FJ" Commercial) the oil drainage from the timing gear cover was improved to reduce the oil level in the cover and thereby minimise the possibility of oil leakage from the timing cover oil seal. At the same time, a vent hole was added to the front face of the cylinder block and engine support plate. In order to achieve improved oil drainage, the following changes have been introduced in production:--

1. Oil drainage holes in the front main bearing cap have been lowered by approximately 1/2 in. (see Fig. 1).
2. A vent hole 1/2 in. dia. added to front face of cylinder block beneath the camshaft bearing bore adjacent to a line taken from the camshaft and crankshaft centre lines (see Fig. 2).

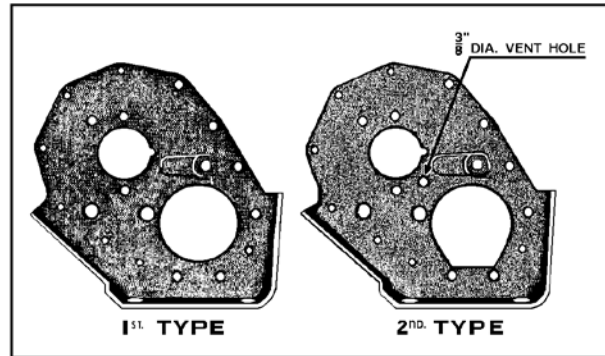
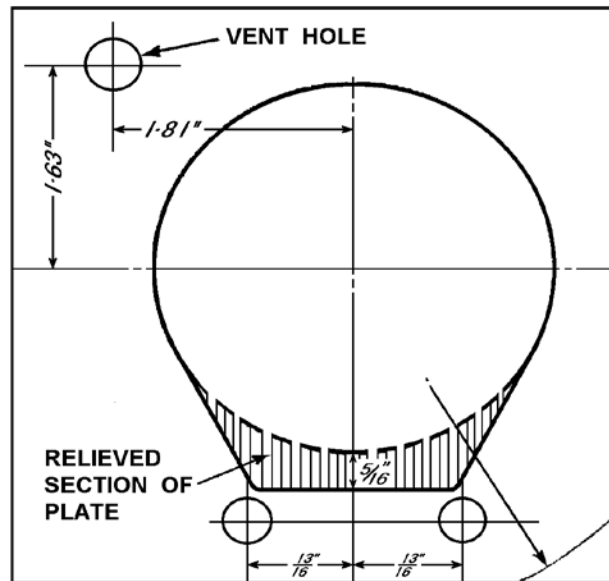
3. A revised type Engine support Plate ("FE"), Part No. 7412006, and gasket, Part No. 7412002, and support plate ("FJ"), Part No. 7412004, and gasket, Part No. 7412003, introduced to suit venting and re-located holes (see Figs. 3 and 4).

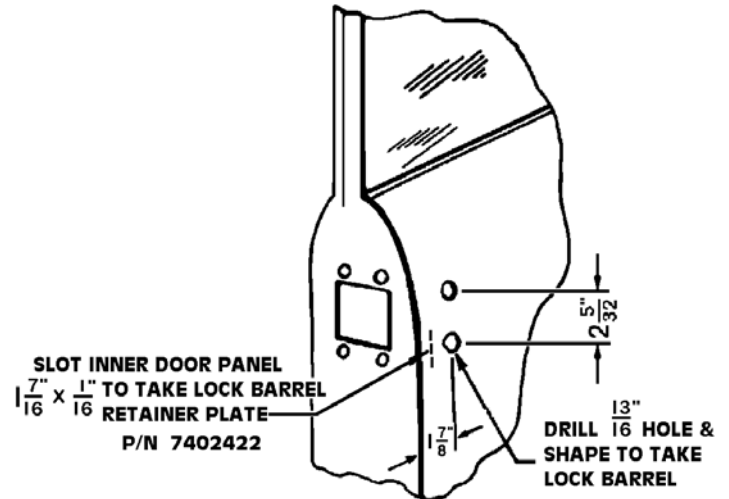
Fig. 5

A recent improvement to the Holden Special Sedan to include a door locking barrel in the R.H. side door in addition to the original in the L.H. door is now in effect.

- (1) The removal of the four bolts which attach the lock cover plate and lock to the door pillar face.
- (2) The drilling of a  $\frac{13}{16}$  dia. hole and filing of edge to accommodate the irregular shape of the lock barrel (see Fig. 5).
- (3) The slotting of the door pillar facing to receive the lock Barrel retainer plate, Part No. 7402422.

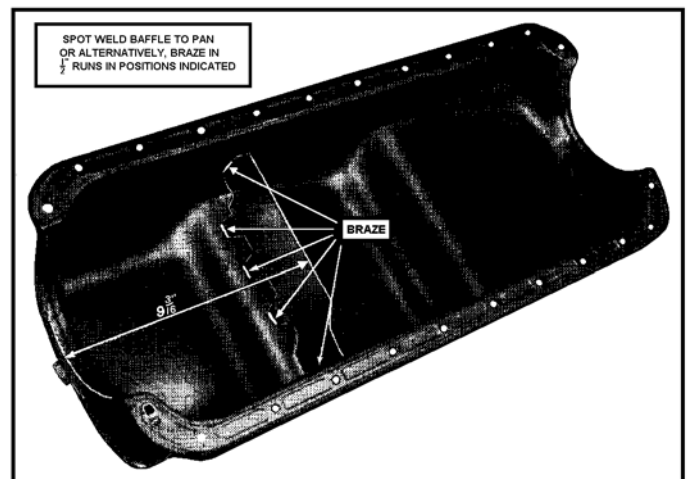
Fig. 1

Following on Holden Bulletin H94-G, which advised of the introduction of engine oil pans equipped with baffle to reduce the tendency of oil surge on brake application, NASCO has advised that the baffles are now available as a separate component under Part No. 7409654. If desired, the baffle can be fitted to existing oil pans as follows:--

1. Raise the vehicle and place it on jack stands.
2. Drain the oil pan, remove the engine front splash pan and remove the engine breather tube assembly from the push rod cover and oil pan.
3. Remove the pitman arm attaching nut, withdraw the pitman arm and push the steering connecting rod assembly to one side.
4. Remove the oil pan attaching screws and remove the oil pan.
5. Thoroughly clean all traces of oil and sludge from oil pan.
6. Locate baffle in oil pan  $9\frac{3}{16}$  in. from extreme rear end of the pan, with the flanges facing the rear and spot weld in position (Fig. 1).

If no spot welding equipment is available, braze the baffle in position in 4 or 5 places, using  $\frac{1}{2}$  in. runs.

*Caution:* Do not use excessive heat as distortion of the oil pan attaching flange or blow holes may result.

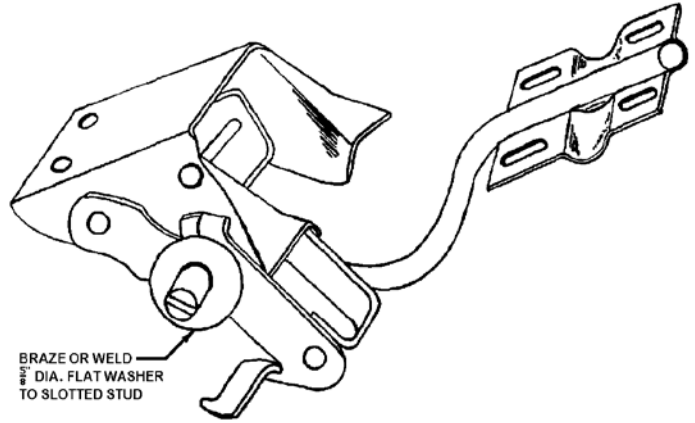
Fig. 1

Trunk lid hinges that have been strained through misalignment or rough usage to the extent that the stop overrides the linkage, can invariably be repaired without removal of hinge.

- (1) Remove the hinge spring from the hinge.
- (2) Straighten the pivoting links and re-locate them in correct relationship to each other prior to tightening rivets where necessary.
- (3) Locate and weld 5/8 flat washer over and to the special slotted stud as in Fig. 1.  
*Note:* Protect Paint finish from becoming damaged by packing wet insulation around the weld location.
- (4) Replace the hinge spring and touch up paint finish if required.

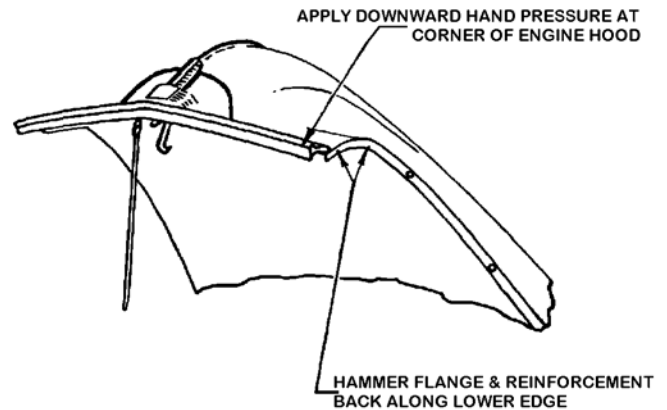
Fig. 4

Investigation into recent reports on poor fitting Engine Hood and Hood Grille in relation to front fender and grille corner sections shows that in some cases there is a little more re-working required than normal adjustment.

When such a condition necessitates the re-forming or shaping of the forward contour of the Engine Hood this can be achieved by raising the Engine Hood and hammer setting the hood flange and reinforcement at locations shown in Fig. 4.

During the setting operation, apply hand pressure to the grille bar or engine hood front corner.

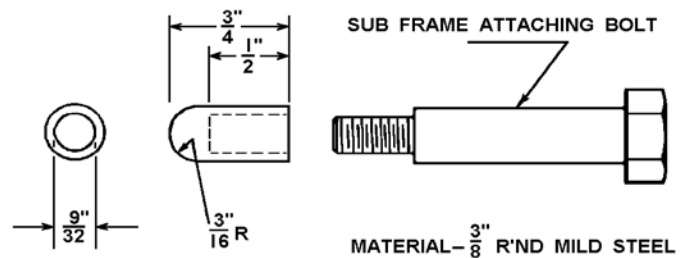
Fig. 1

When replacing a front sub-frame or a sub-frame attaching blot the threaded end of the shouldered bolt sometimes becomes damaged.

The operation of replacing or entering the bolt can be simplified and damage prevented by fabricating a small metal protective cap shaped like the nose of a bullet to fit over the threaded end of the bolt (see Fig. 2).

**NOTE:—**  
CAP CAN BE CASE HARDENED WHERE WARRANTED
