# TIMING COVER VENT AND DRAIN HOLES

## DOOR LOCKING BARREL

## ENGINE OIL PAN BAFFLE - FITMENT PROCEDURE

# TRUNK LID HINGE REPAIRS

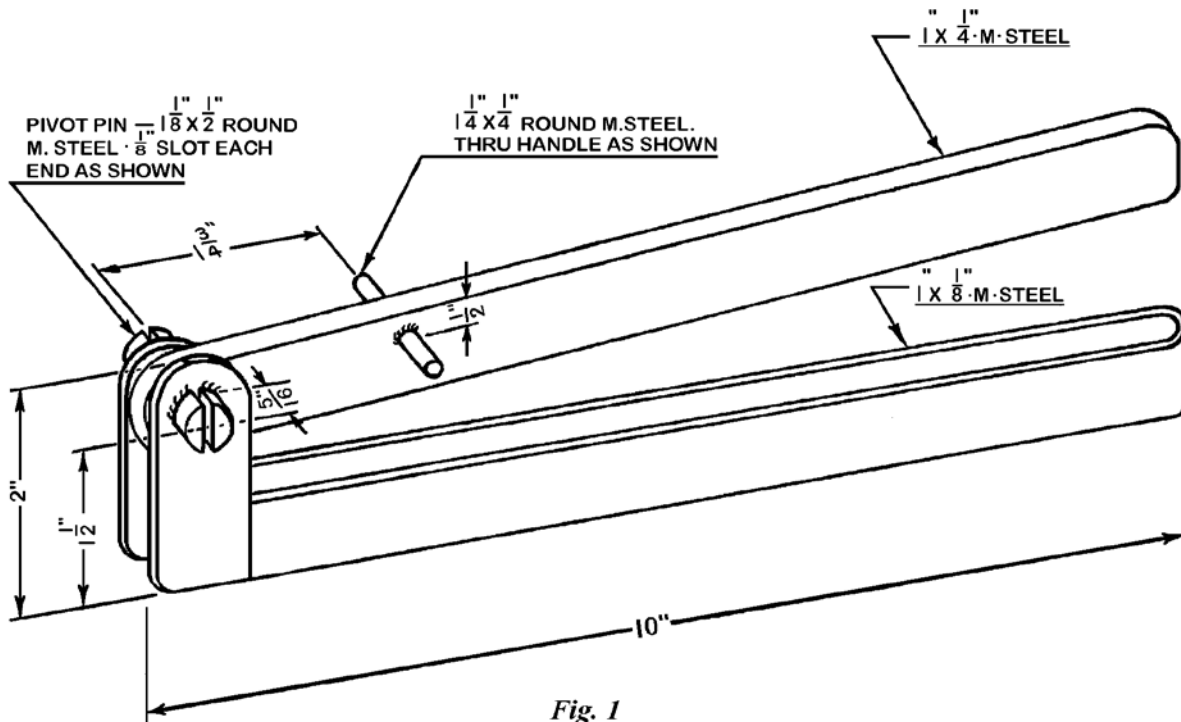
Fig. 1

The installation of the trunk lid hinge spring is normally carried out by means of a wire loop placed over the hooked end of the spring, following the spring engagement in the slotted pivot arm. However, requests for a tool from some operators who perform the operation more frequently than others, has resulted in the development of a tool (see Fig. 1) which, under test, has proved effective.

The spring is simply placed on the tool with the arms extended; the tool is then closed to retract the spring for installing.

From the dimensions shown, and its simple construction, the tool can be readily fabricated by operators who desire to use it.

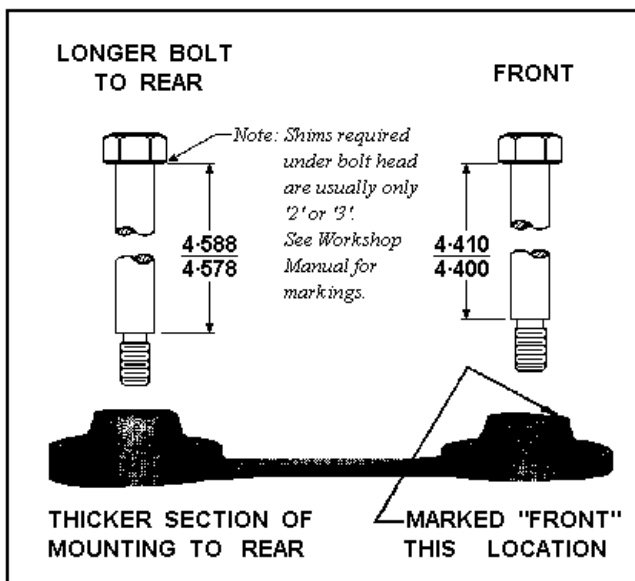
Fig. 1

Part No.	Length between under side of bolt head and shoulder at threaded end	Where Used
7400122	4.410 in. to 4.400 in. Nominal 4-13/32 in. (approx. 112mm)	At front at all times — also — at rear only on original single rubber type mounting.
7405875 Part of package No. 7405879	4.690 in. to 4.680 in. Nominal 4-11/16 in. (approx. 119mm)	At rear only when the service thicker type rubber is used at rear of mounting.
7408659	4.588 in. to 4.578 in. Nominal 4-37/64 in. (approx. 116mm)	At rear when one piece construction rubber is used at mounting
